Constructing a Cutoff Wall in Front of Walter F. George Dam in 100 Feet of Water

To combat seepage at the dam of the 130-MW Walter F. George Lock and Powerhouse in the southeastern United States, the U.S. Army Corps of Engineers built a 1,831-foot-long upstream cutoff wall. Installing this wall in water depths of as much as 100 feet without significantly affecting hydro operations taught several valuable lessons about working underwater.

Volume 25, Number 1, March 2006

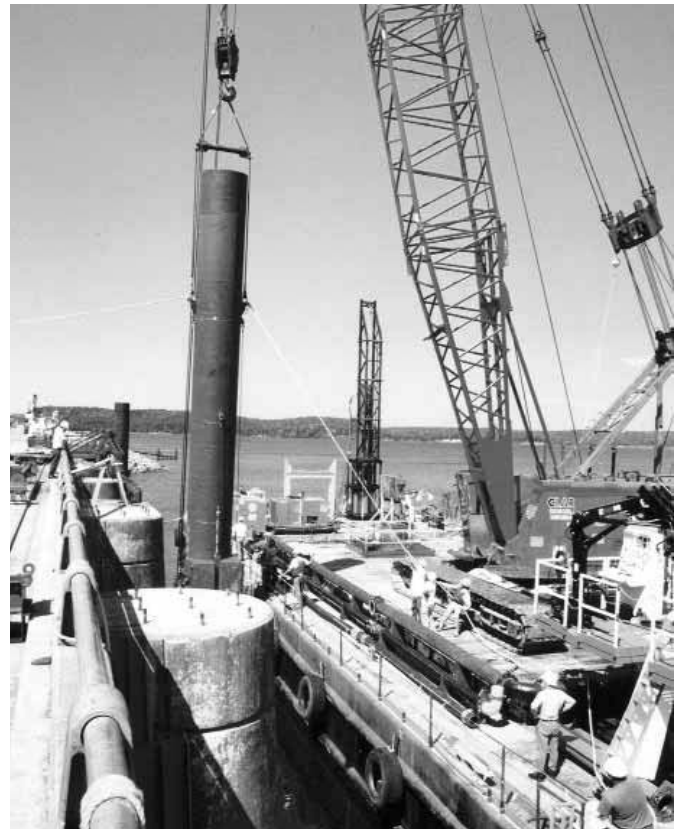
Workers use a barge-mounted crane to place the first of 469 54-inch-diameter casings for construction of the concrete secant wall in front of Walter F. George Dam. The wall is an average distance of 10 feet in front of the dam.

The cranes used to install the casings were mounted on two 54-foot-wide by 180-foot-long by 12-foot-high barges anchored in front of the dam. The anchorage system was a series of steel cables so the barges could be winched into position. The massive cranes picked up the steel casings, weighing 34 tons, in a vertical orientation and lowered them to the bottom of the lake. Each casing was positioned using survey instruments on the perpendicular axis to ensure it was plumb. Finally, the casings were vibrated 8 feet into the working apron. This embedment was intended to isolate the concrete pile from the inflow of lake water during the drilling operation, particularly if cavities were encountered during excavation.

The casings provided the conduit from above the lake's surface to the bottom. The first casing acted as a guide for all future measurements and alignment. The contractor placed a series of primary casings first, followed by a series of secondary casings between the primary casings to form a continuous, overlapping wall.

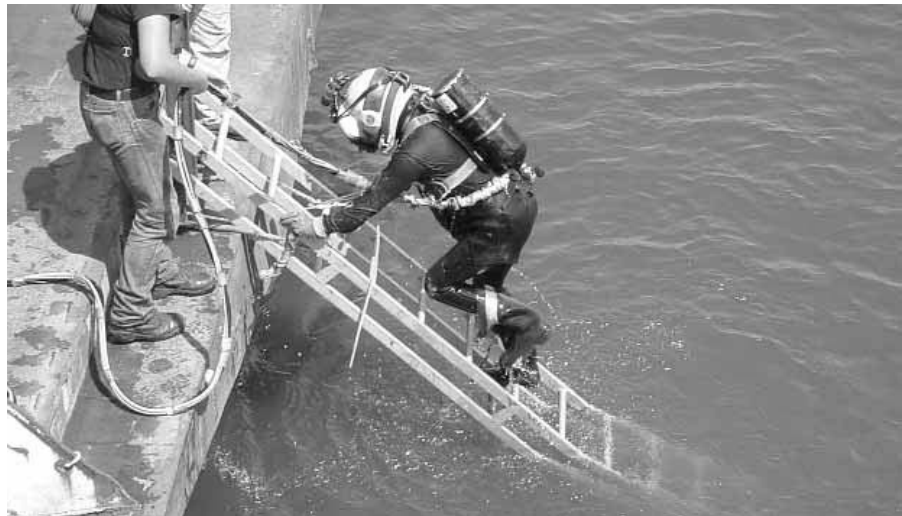
Divers made more than 150 dives to remove a steel coffer cell and other obstructions during construction of the cutoff wall in front of Water F. George Dam. Divers also assisted the project with construction and inspections.

The Corps encountered two major obstructions during this work. The first, a steel sheet pile coffer cell used in the original powerhouse construction, had to be removed because the drill rig could not cut steel. Divers had to cut out the members and raise the cell piece by piece.

In addition, more than 150 dives were made to remove the steel coffer cell and other obstructions. More than 100 of these dives required decompression. Total diving work for the project consisted of 120 deep-water dives requiring decompression and 69 shallow-water dives of 30 feet or less. By comparison, the Corps' Mobile District normally averages 22 dives a year.
